Manhole Inspection Summary

Manhole # S21MM_003MH

Insp Date: **3/11/09 11:02 AM**

Location Address: **1571 RICHLAND ST**

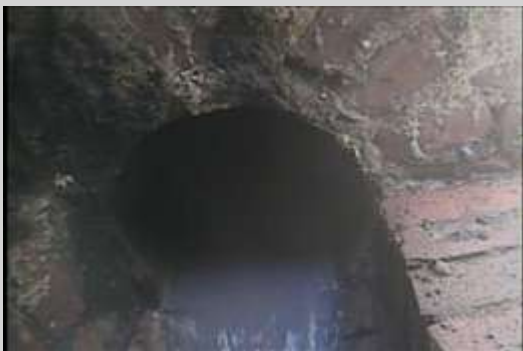
3 O'Clock Inflow

10 in. Circular Gravity Sewer
Pipe In @ 3 O'Clock

Pipe Height: **10.8** (in.) Rod and Bar (Angled)
Pipe Material: **Clay** ☐ Pipe Lined
Invert Depth: **7.40** (ft.) Flow Characteristics: **Slow**
Deposits: ☒ None ☐ Mud ☐ Sludge ☐ **Debris** ☐ Grease
Silt Depth: **0** (in.) Deposits Extent: **Light**
Infiltration: **None** Pipe Seal Cond: **Sound**
